2015 COMPLIANCE REPORT FOR EPBC APPROVAL 2008/4250

AVON RIDGE ESTATE, BRIGADOON

Project Number EP13-041

Prepared for Peet Ltd.
September 2015

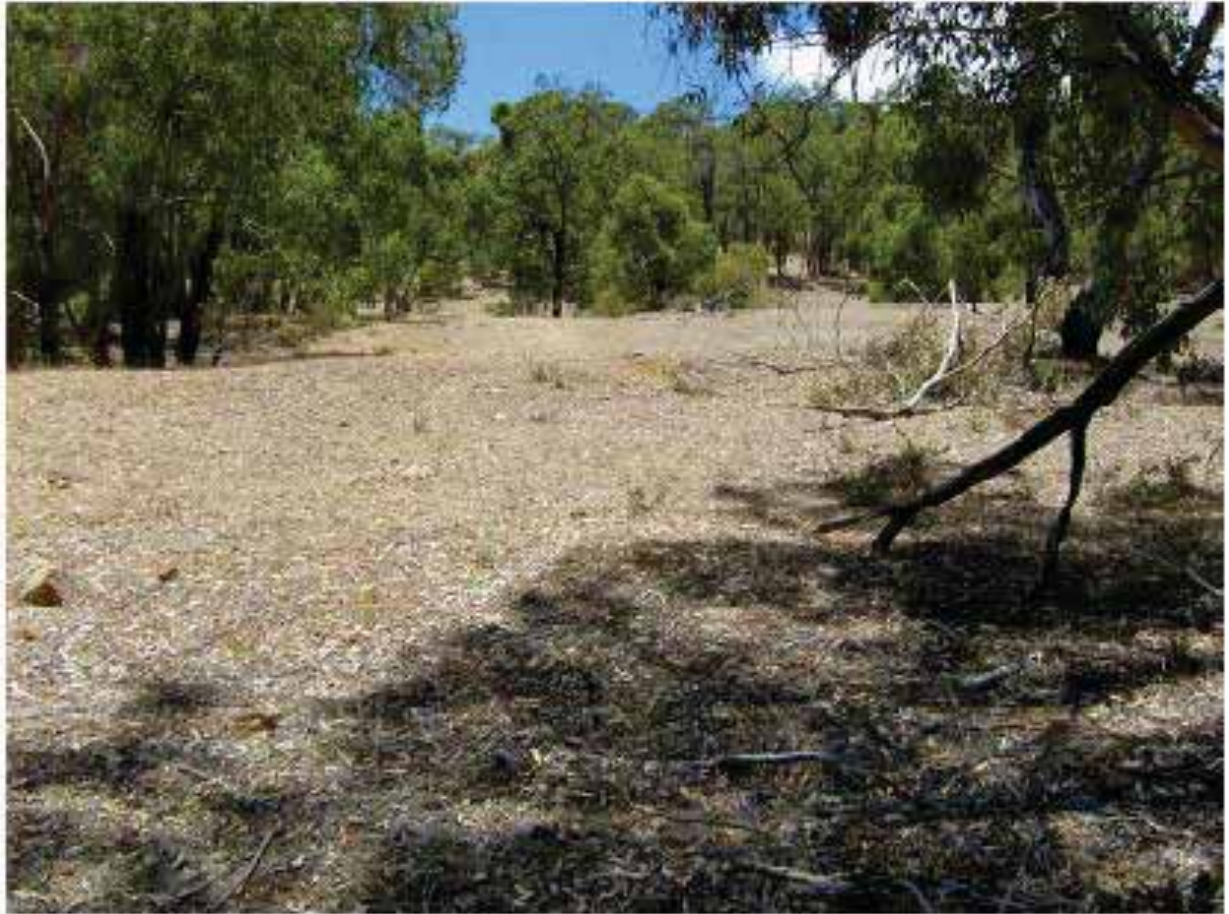
Revegetation commenced in 2011 and the majority of plantings have been undertaken within the flatter, degraded areas within the PR Reserve shown in **Figure 5**. These flatter areas do not contain extensive gravel which would inhibit revegetation success. These areas have previously been cleared for grazing and the general condition of the areas proposed for revegetation is shown in **Plate 1**.

Plate 1: “Completely Degraded” or parkland cleared area within Parks and Recreation Reserve identified for revegetation works (Cardno 2010a)

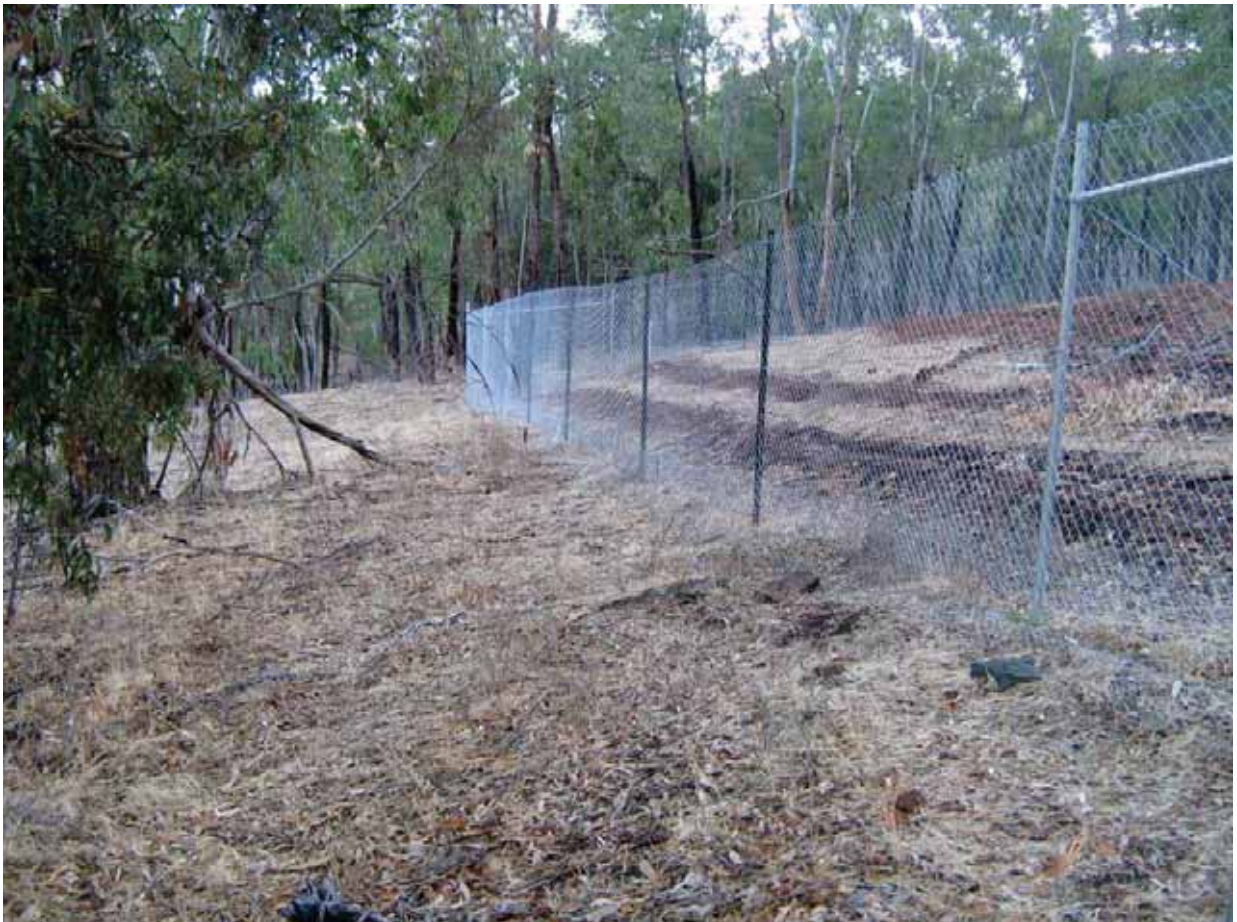
Four of the six revegetation sites were fenced (**Plate 2**). Two sites were not able to be fenced due to amenity issues from adjacent lot owners and/or the steep nature of the revegetation sites, which made it impractical to install fencing. Plants within these unfenced sites experienced higher herbivory and additional infill planting was undertaken to ensure the completion criteria could be met (see **Section 4**).

Plate 2: Fencing around a revegetation site

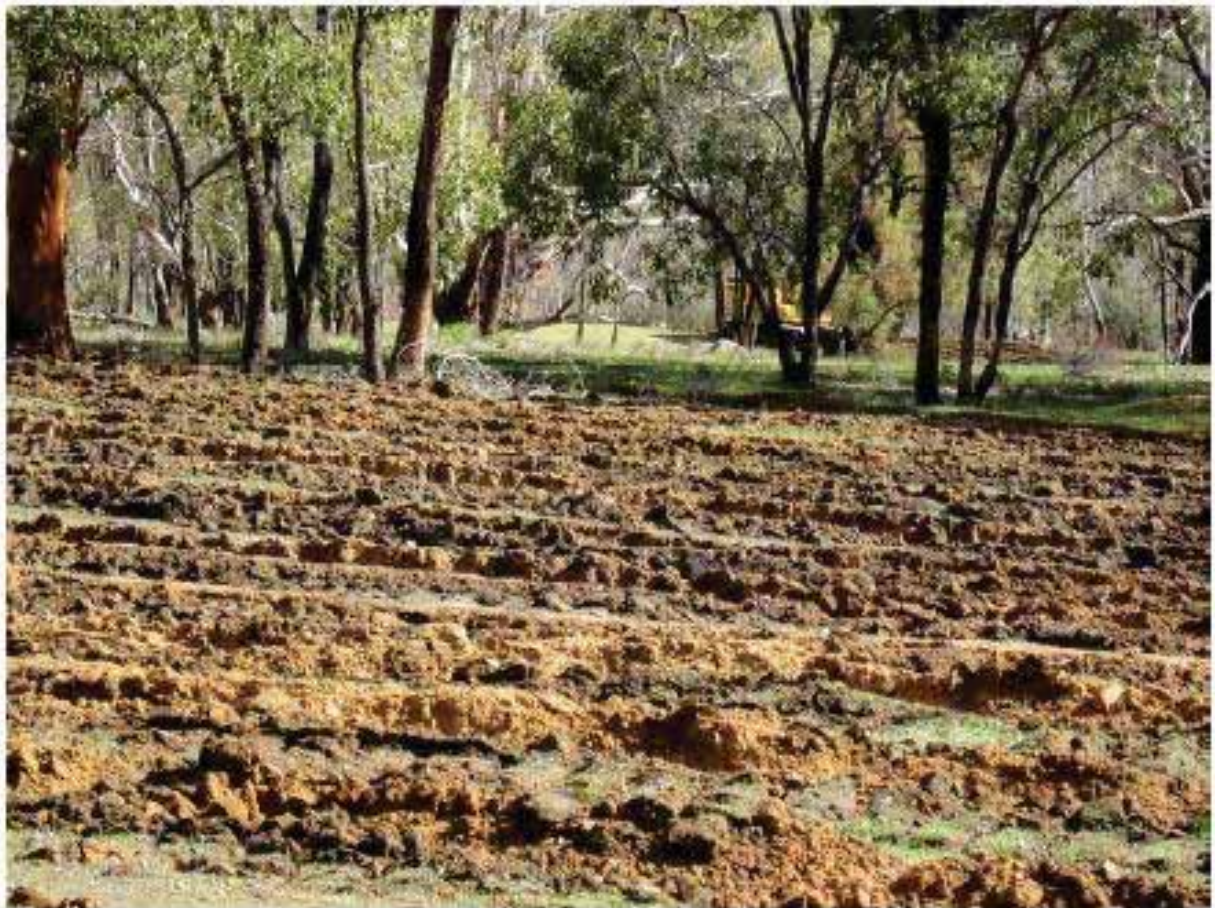
Deep ripping (as shown in **Plate 3**) can lead to increased regeneration of the existing soil seedbank of both weed seeds and native species. The existing revegetation sites were deep ripped to 1 m depth with a tyne, 1.8 m apart. Due to the potential stimulation of the weed soil seedbank following ripping, a pre-emergent herbicide was applied along the rip lines to reduce competition with seedlings. This has proven effective at reducing weed competition but may also have prevented native seeds germinating. Monitoring of revegetation installed in 2011 following deep ripping did not record significant germination or establishment of native species along the rip line from the soil seed bank (ie. in addition to the planted seedlings). It is also likely that given the degraded nature of the PR Reserve that the native soil seed bank has been heavily depleted over time.

Plate 3: Areas showing deep ripped soil (Cardno 2010a)

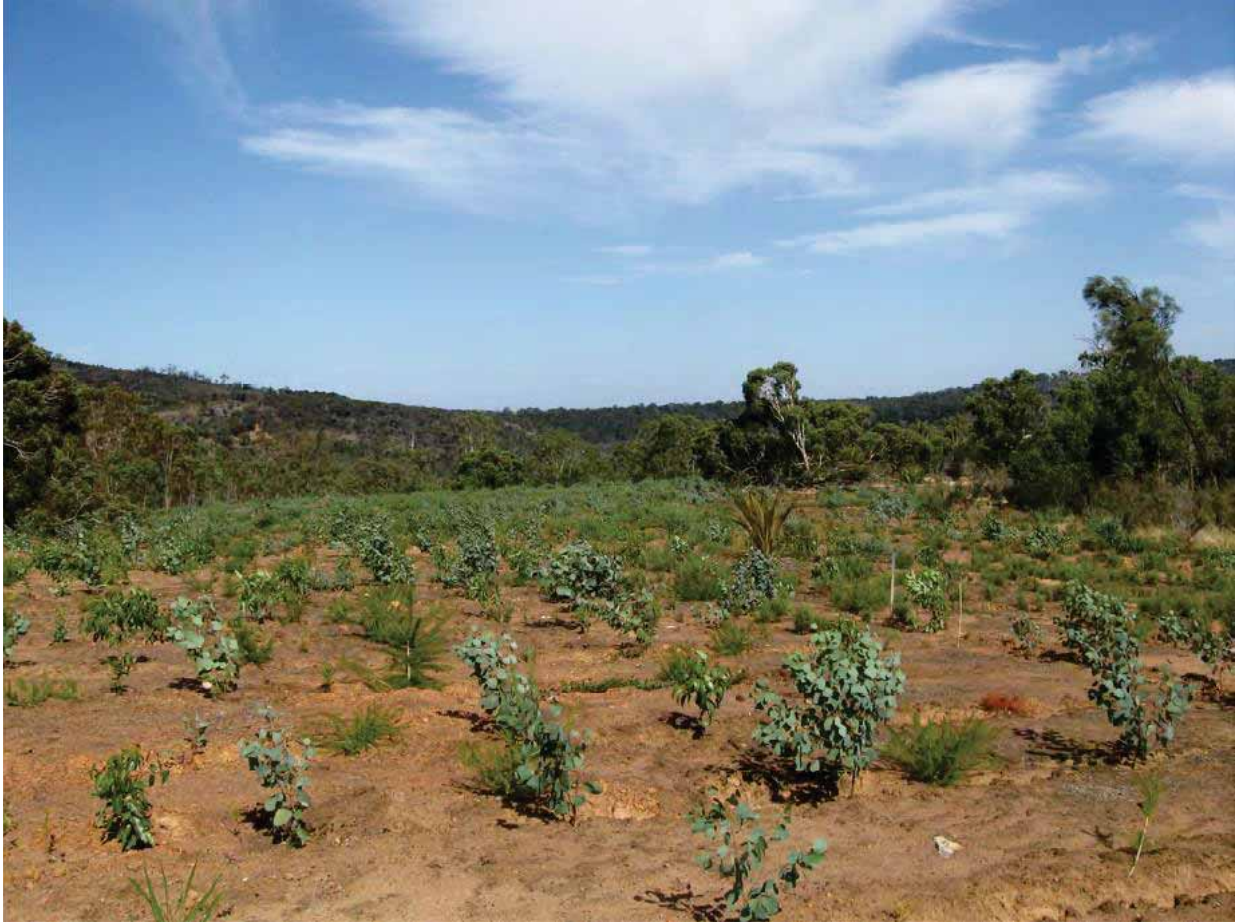
Plate 4: Planting within rip lines (Cardno 2010a)

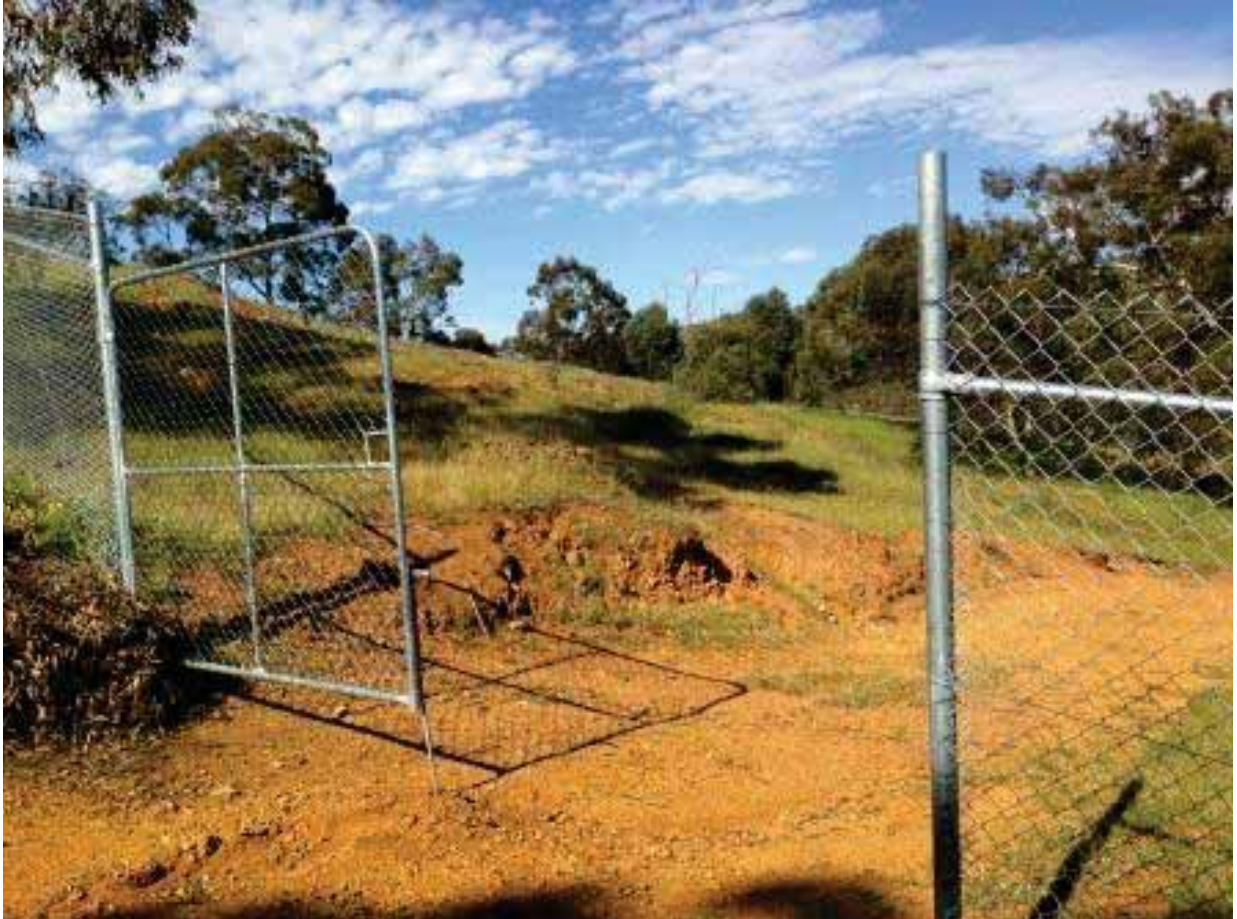
Plate 5: Missing gate at a revegetation site

In areas where fencing and gates were damaged (**Plate 5**), these were repaired.

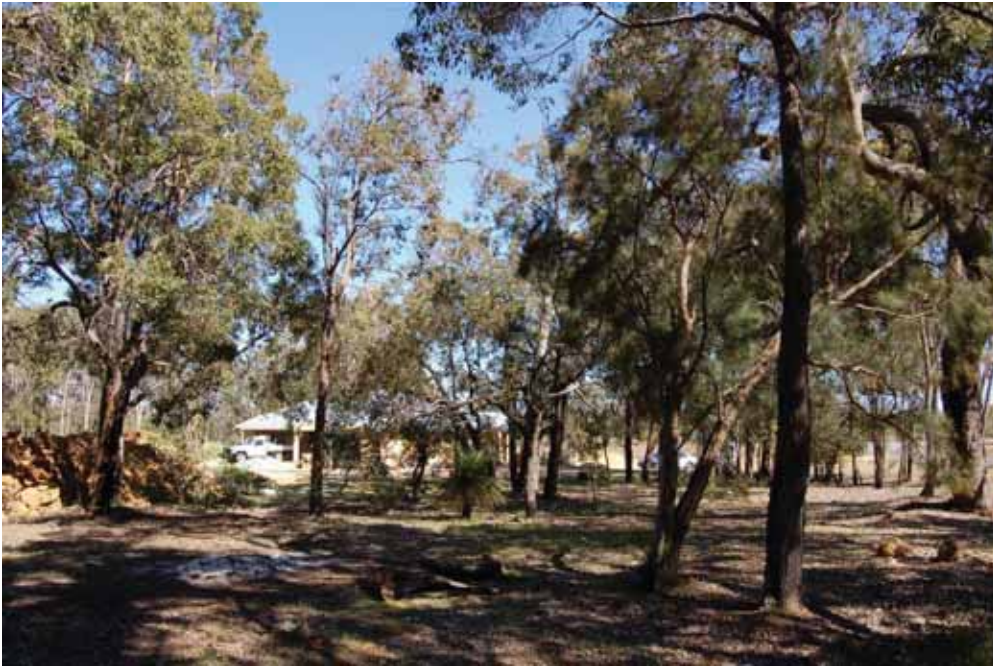
Example of Compliant Building Protection Zone

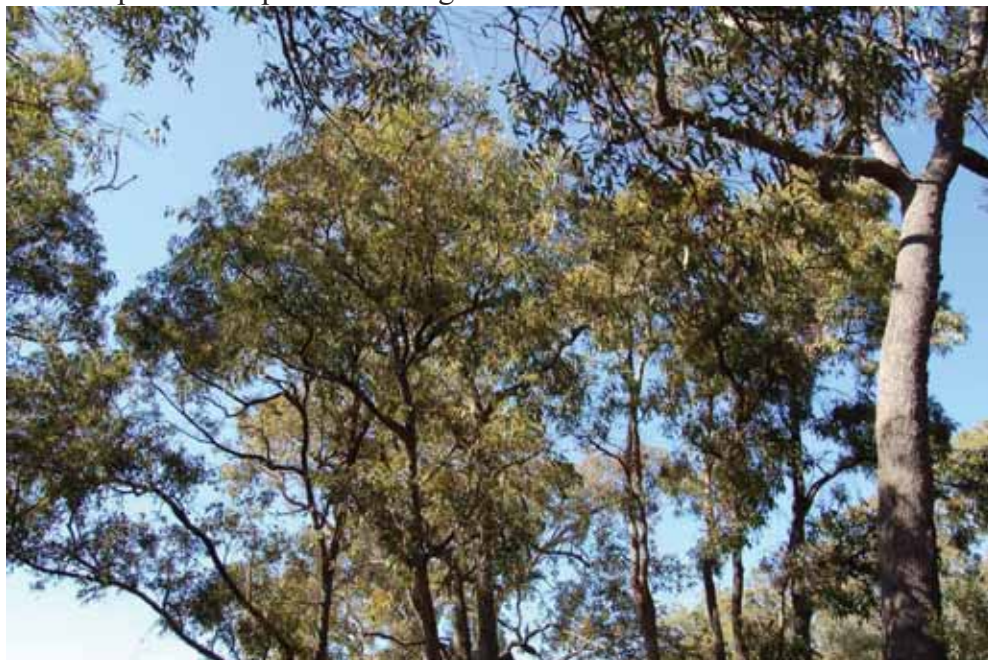
Example of Compliant canopy Tree crowns not touching

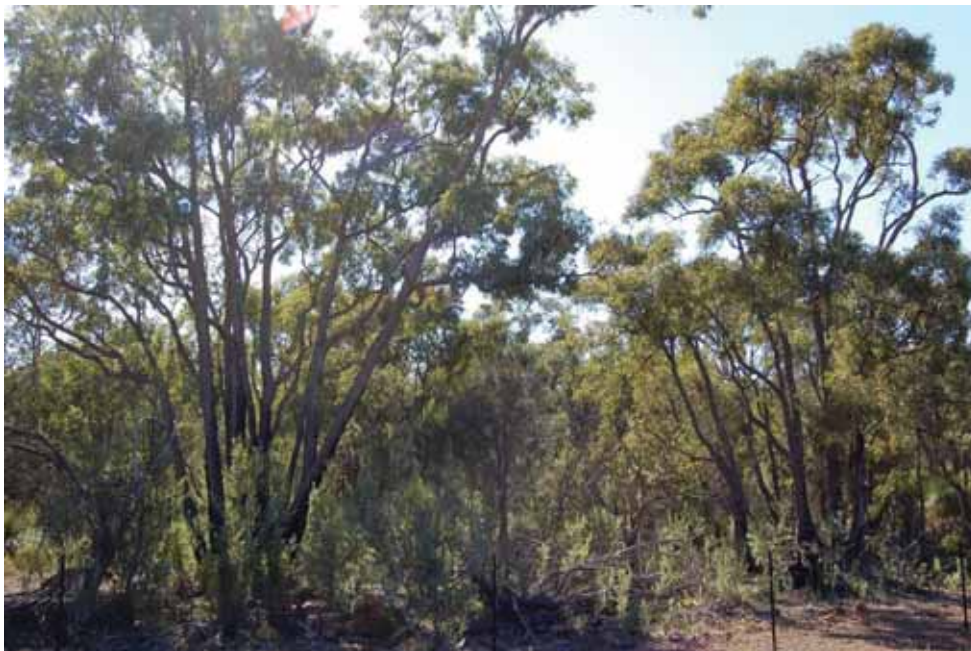
Compliant Hazard Separation Zone Bush Fire Fuels to be maintained below 4-6 tonnes/ha

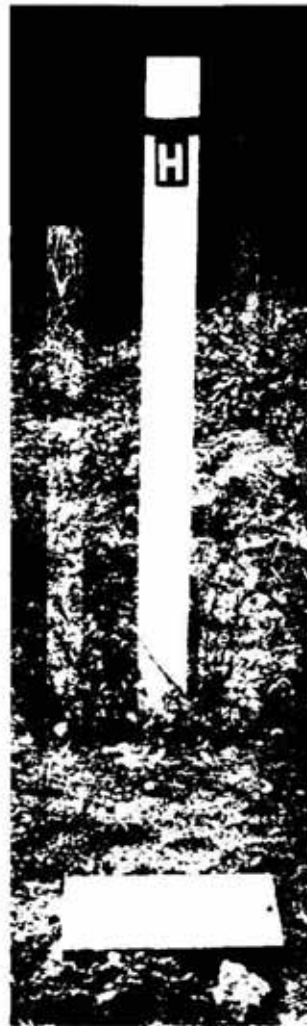
Hydrant indicators post.

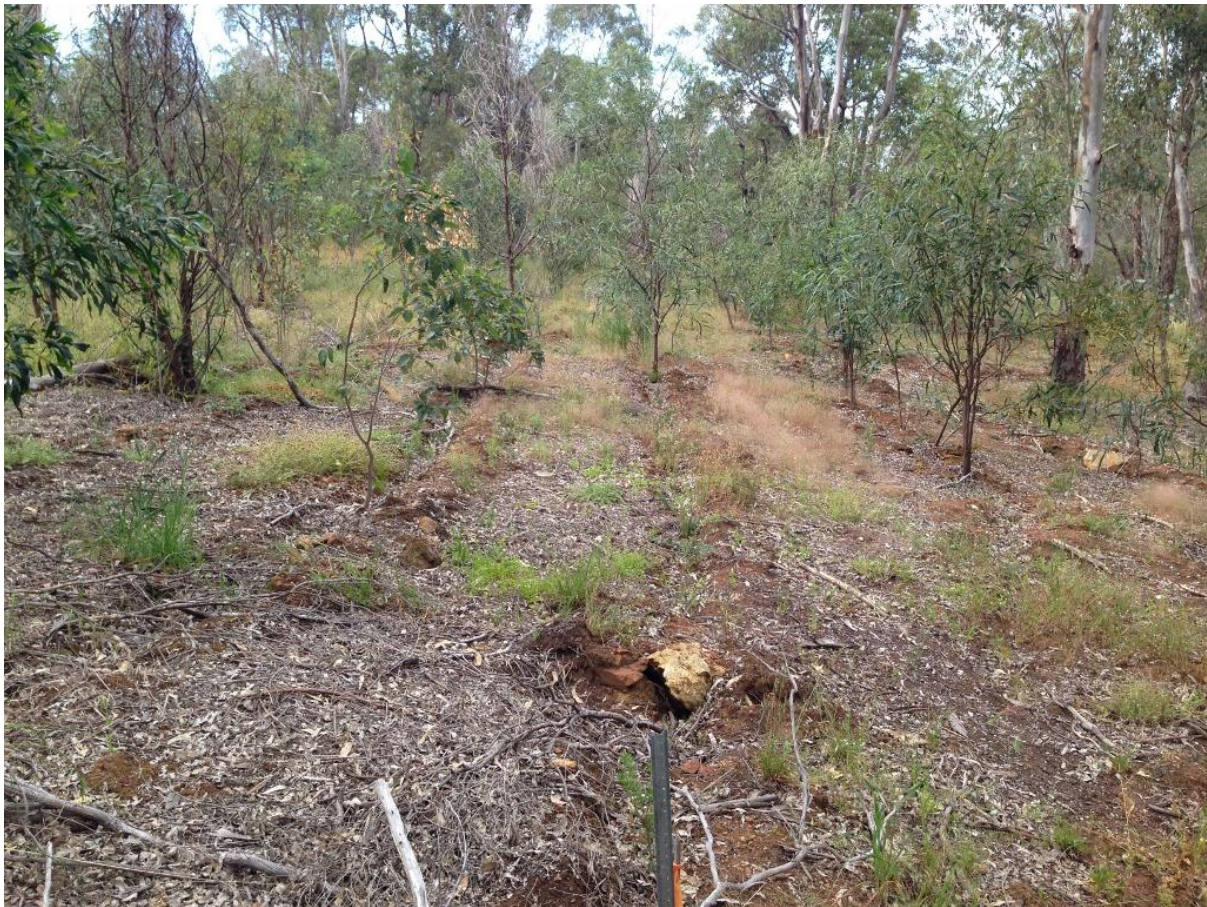
- Additional planting:
 - 12,000 seedlings in August 2012;
 - 9,300 seedlings in July and August 2014;
- Fencing repair (2013);
- Weed control maintenance:
 - Spring 2011;
 - Summer, autumn and spring 2012;
 - Winter 2013;
 - Autumn and spring 2014.

Figure 1 Site 1A – Transect #40 Shows the Developing Plants Installed in 2011

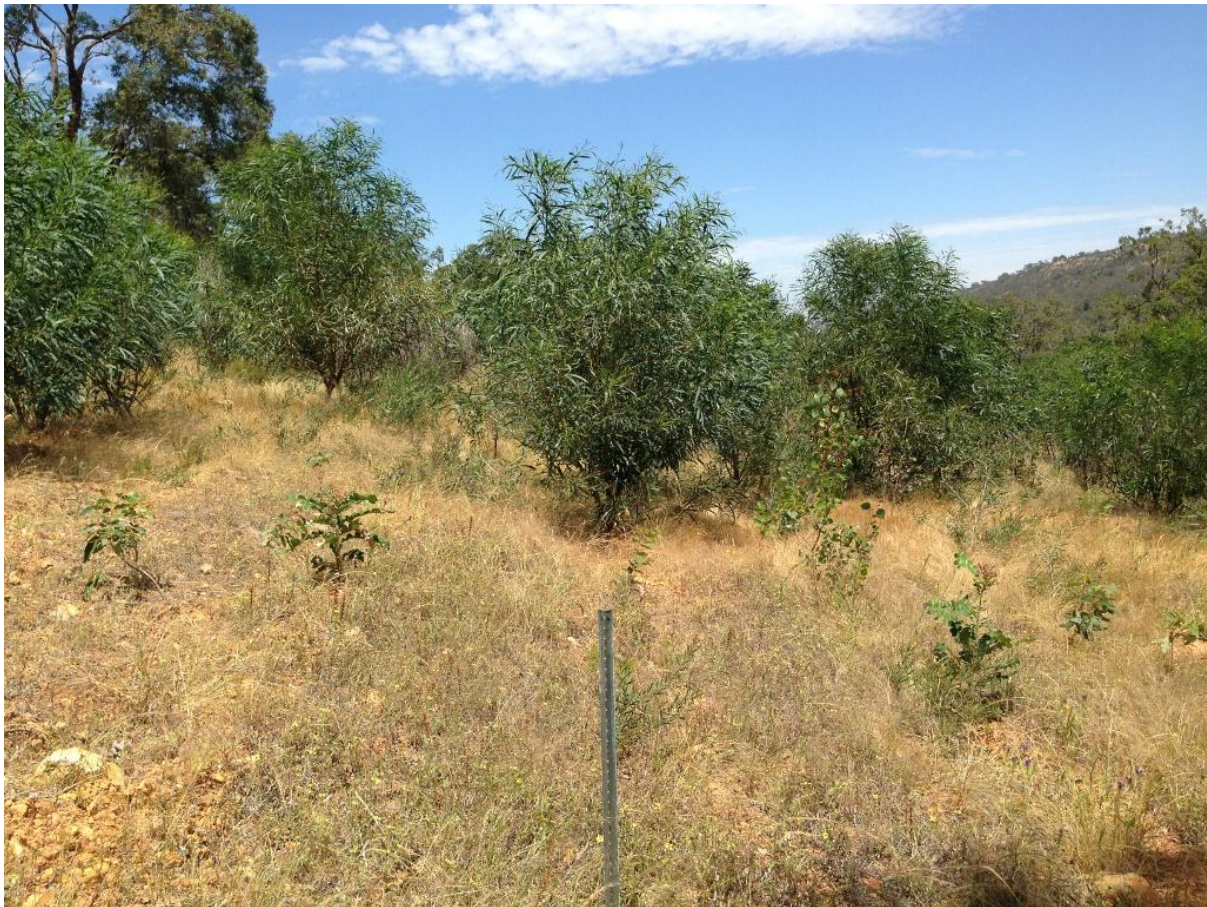
- Fencing repair (2012);
- Additional planting:
 - 6,520 seedlings in June and July 2013;
 - 2,000 seedlings in July 2014;
- Weed control maintenance:
 - Spring 2012;
 - Summer 2012/13;
 - Autumn 2013; and
 - Autumn 2014.

Figure 2 **Site 2 – Transect # 19**

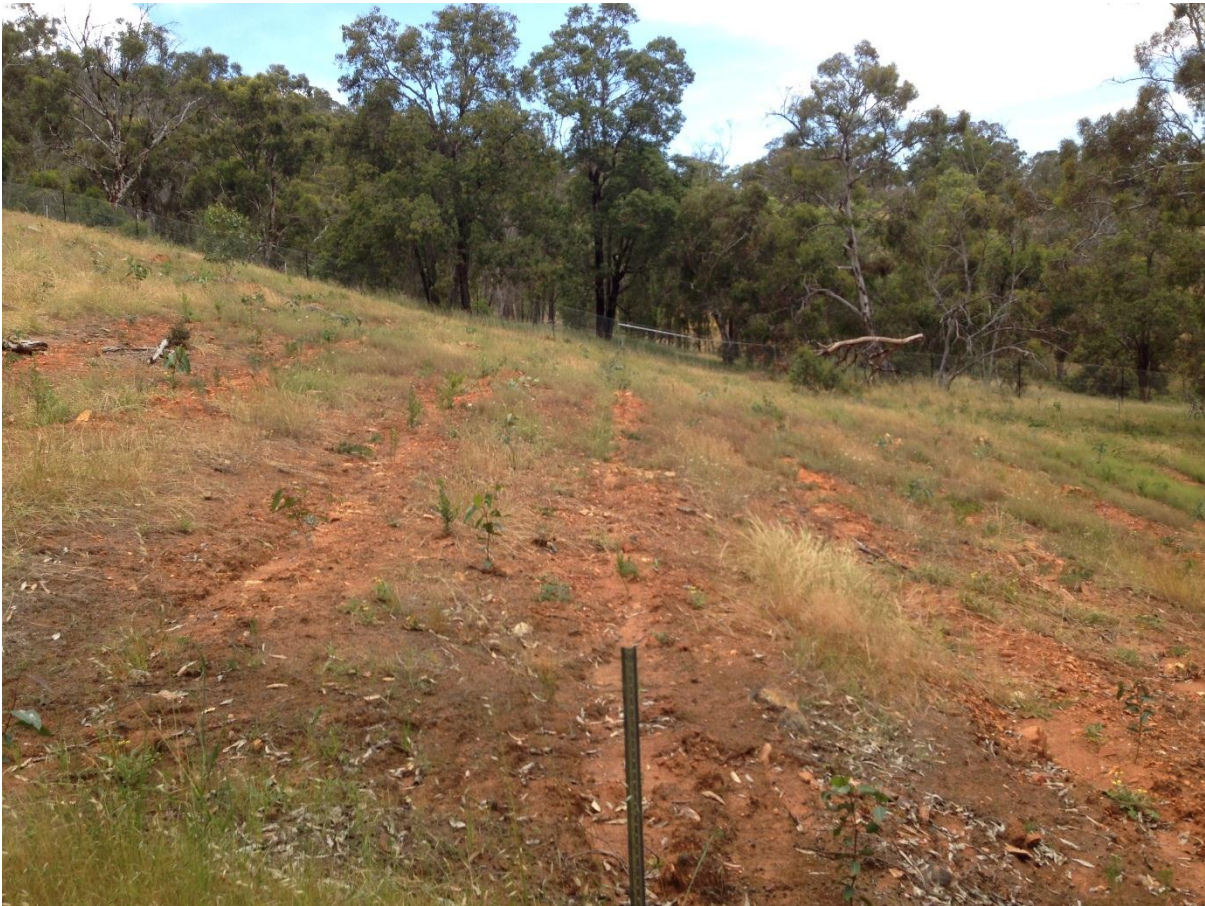
- Installation of a kangaroo fence with rabbit proof skirt measuring 259 m long and 1.8 m high in autumn 2014;
- Weed control in autumn 2014; and
- Planting of 3,800 seedlings in July 2014.

Figure 3 Site 3 – Transect # 4

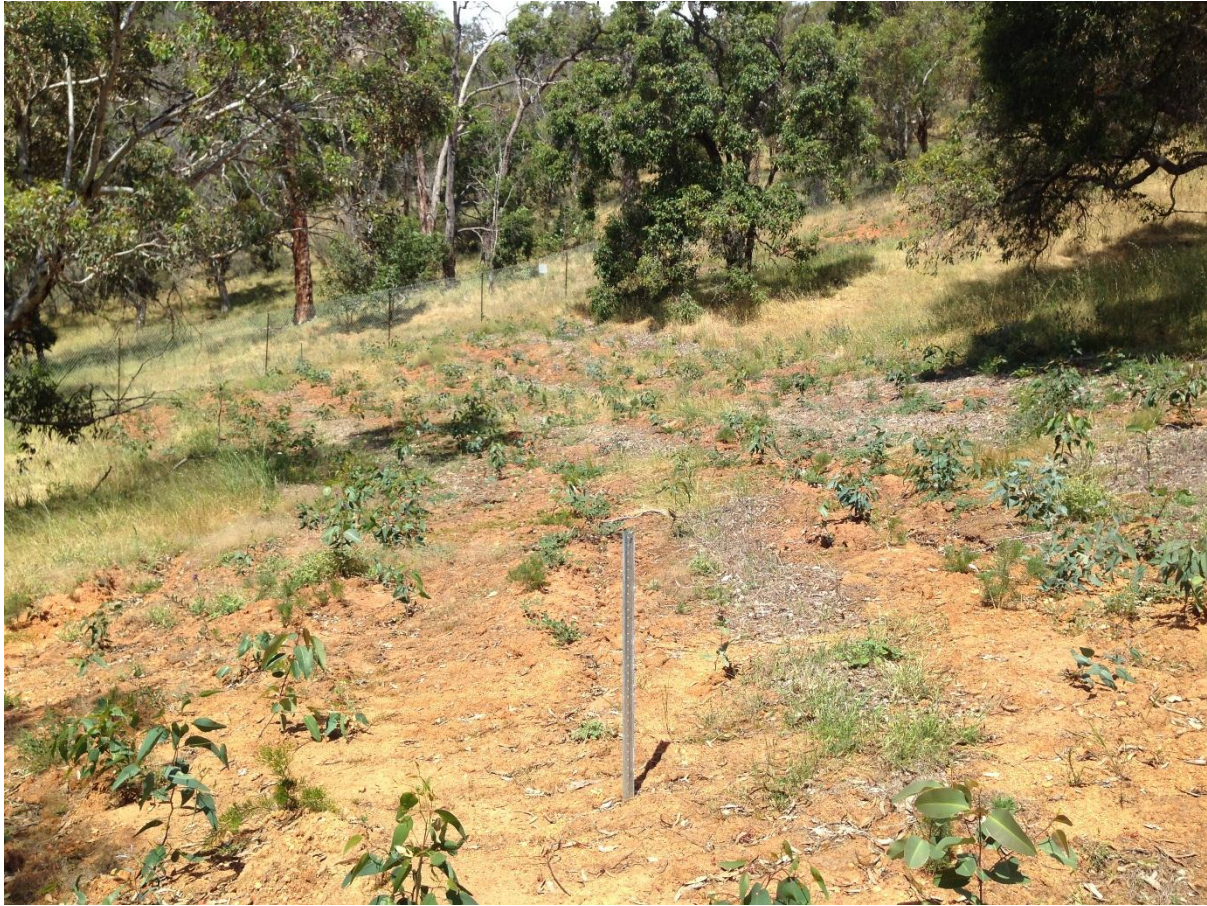
- Additional fencing was erected on both sides of the middle track during April 2014. This was necessary because members of the public were leaving the gates open on the middle track through which kangaroos were entering the site; and
- Planting of 14,800 seedlings in July 2014.

Figure 4 Site 4 – Transect # 3

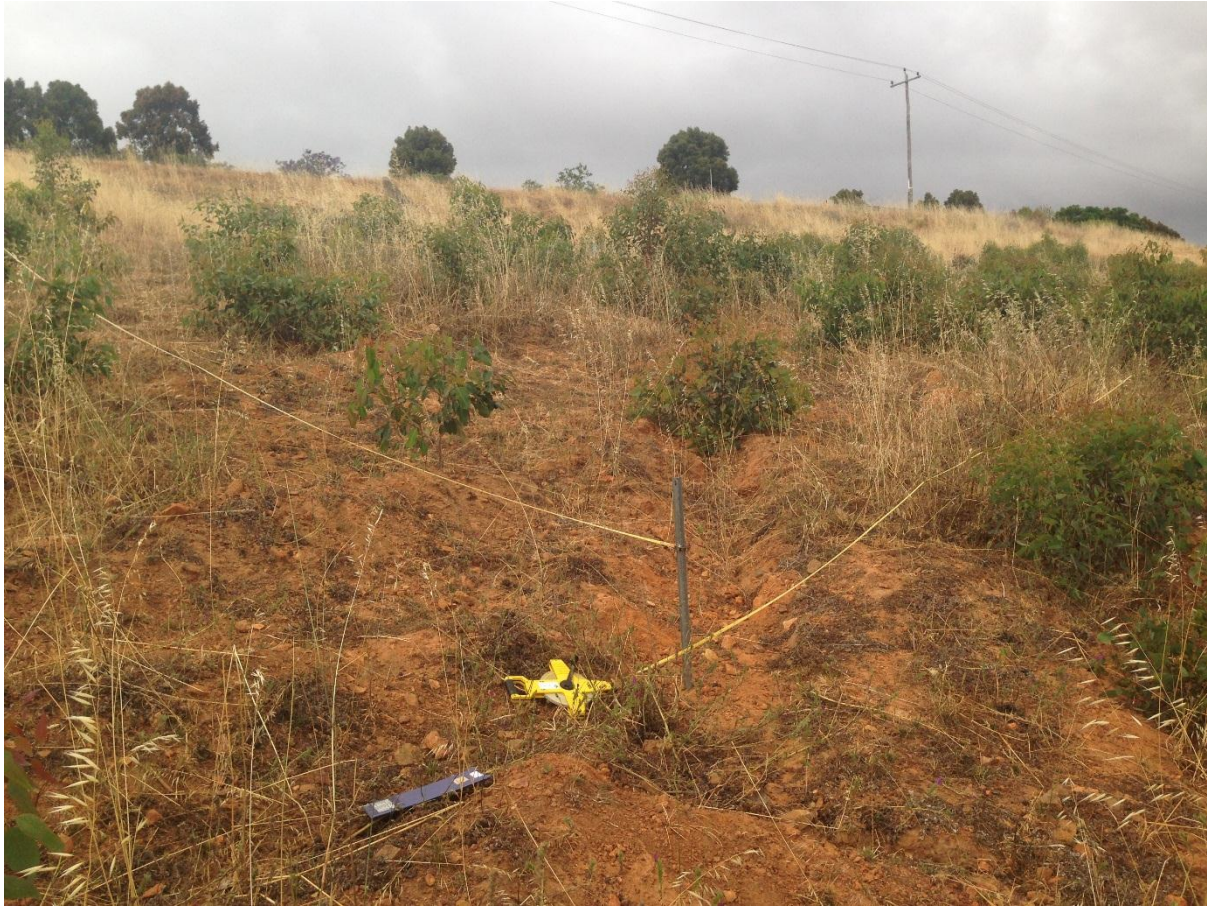
Figure 5 Sales Office A – Quadrat # 2 Showing Strong Growth of Eucalypts

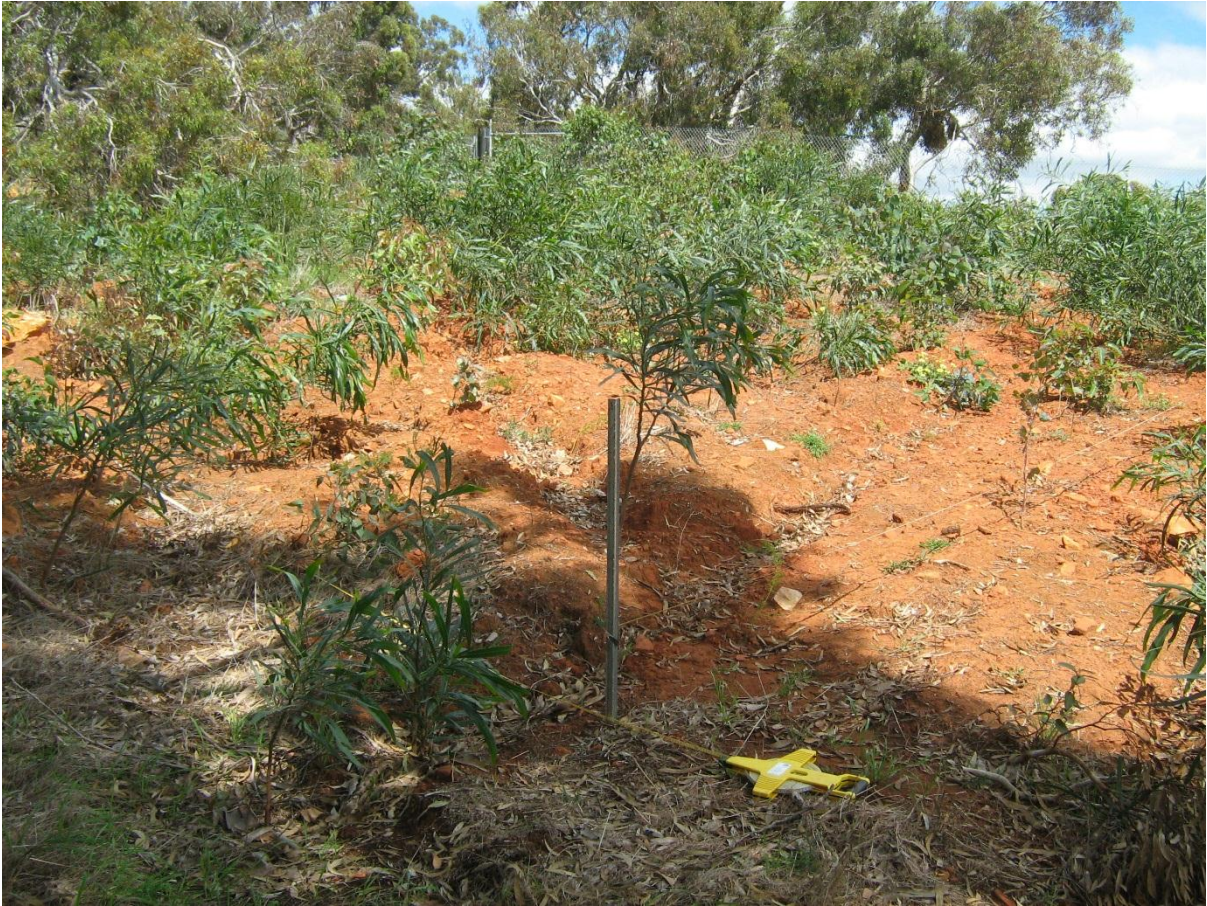
Figure 6 Sales Office B – Quadrat # 3 Showing Good Plant Growth

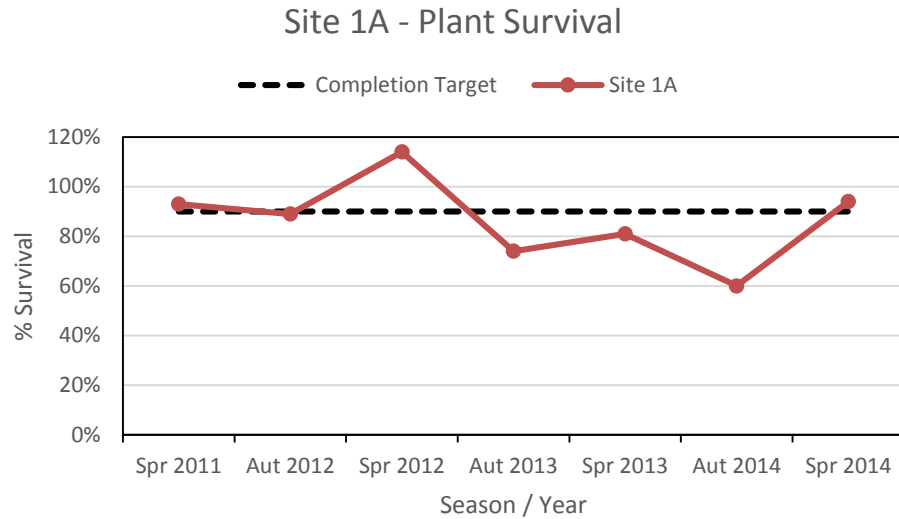
The previous monitoring report (autumn 2014) noted the death of some plants due to the severe drought experienced in the summer of 2013/14. There were some saplings that have resprouted since that time.

Figure 7 Site 1A – Plant Survival Since Site Establishment

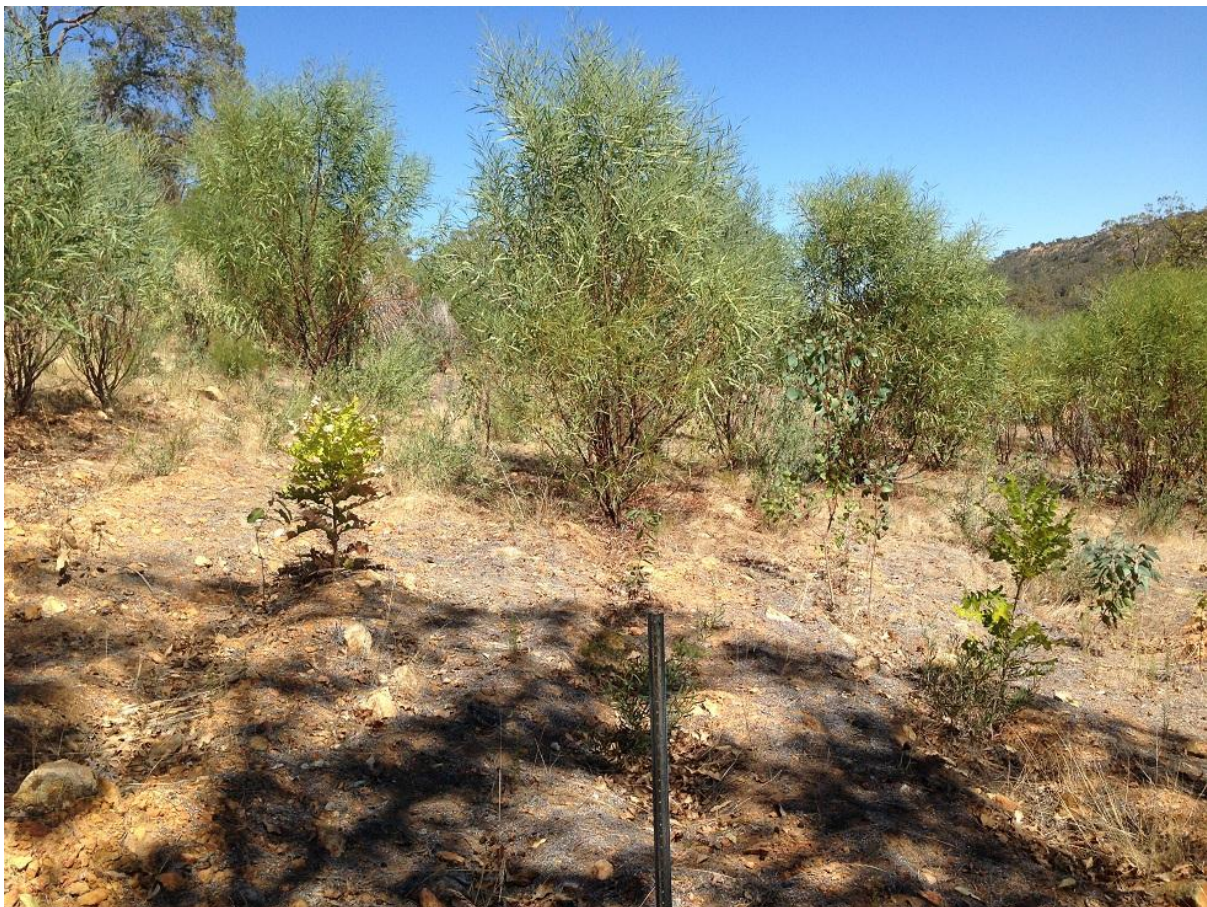
Figure 1 Site 2 – Transect # 19

Since the initial installation the following maintenance activities have been undertaken at Site 2:

- Fencing repair (2012);
- Additional planting:
 - 6,520 seedlings in June and July 2013;
 - 2,000 seedlings in July 2014;
- Weed control maintenance:
 - Spring 2012;
 - Summer 2012/13;
 - Autumn 2013; and
 - Autumn 2014.

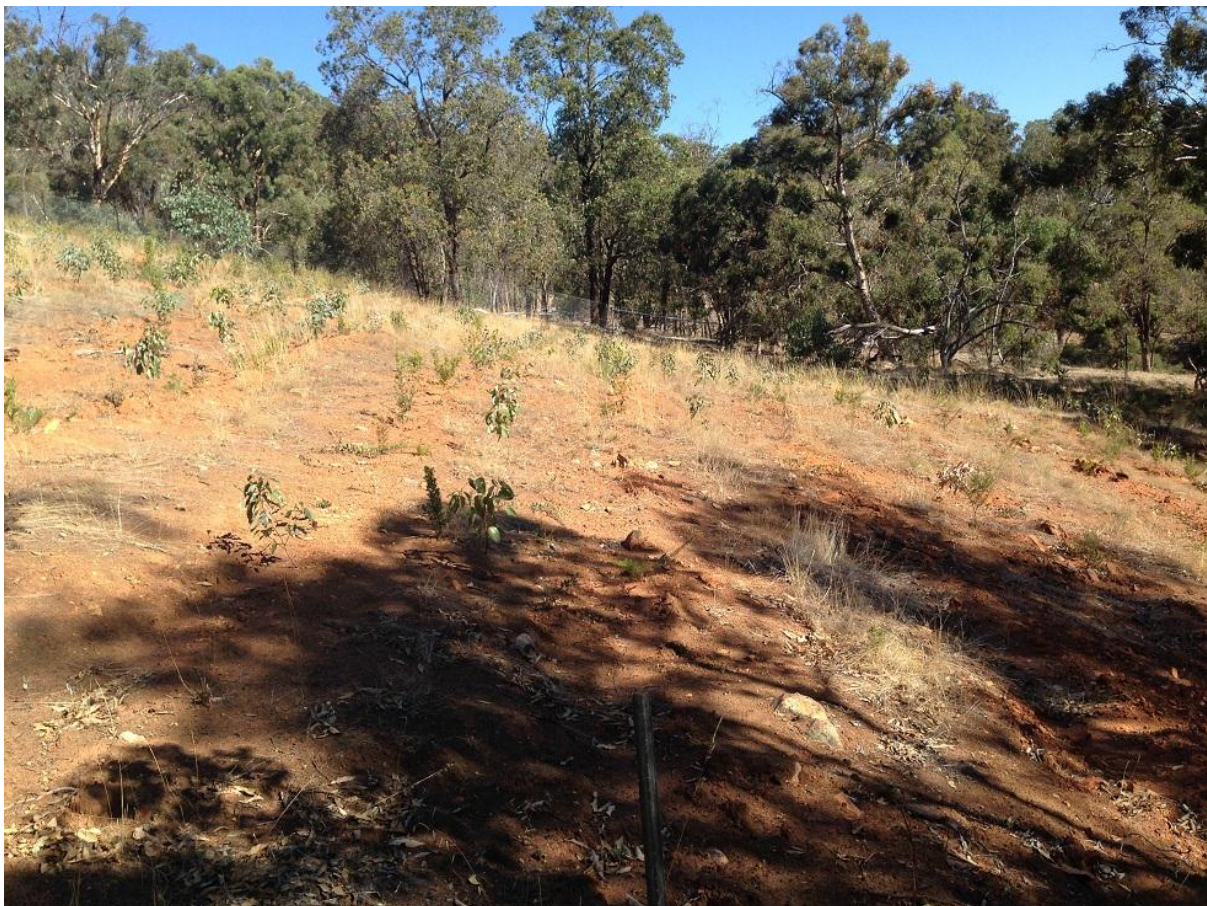
Figure 2 Site 3 – Transect # 4

Since the initial installation the following maintenance activities have been undertaken at Site 3:

- Installation of a kangaroo fence with rabbit proof skirt measuring 259 m long and 1.8 m high in autumn 2014;
- Weed control in autumn 2014; and
- Planting of 3,800 seedlings in July 2014.

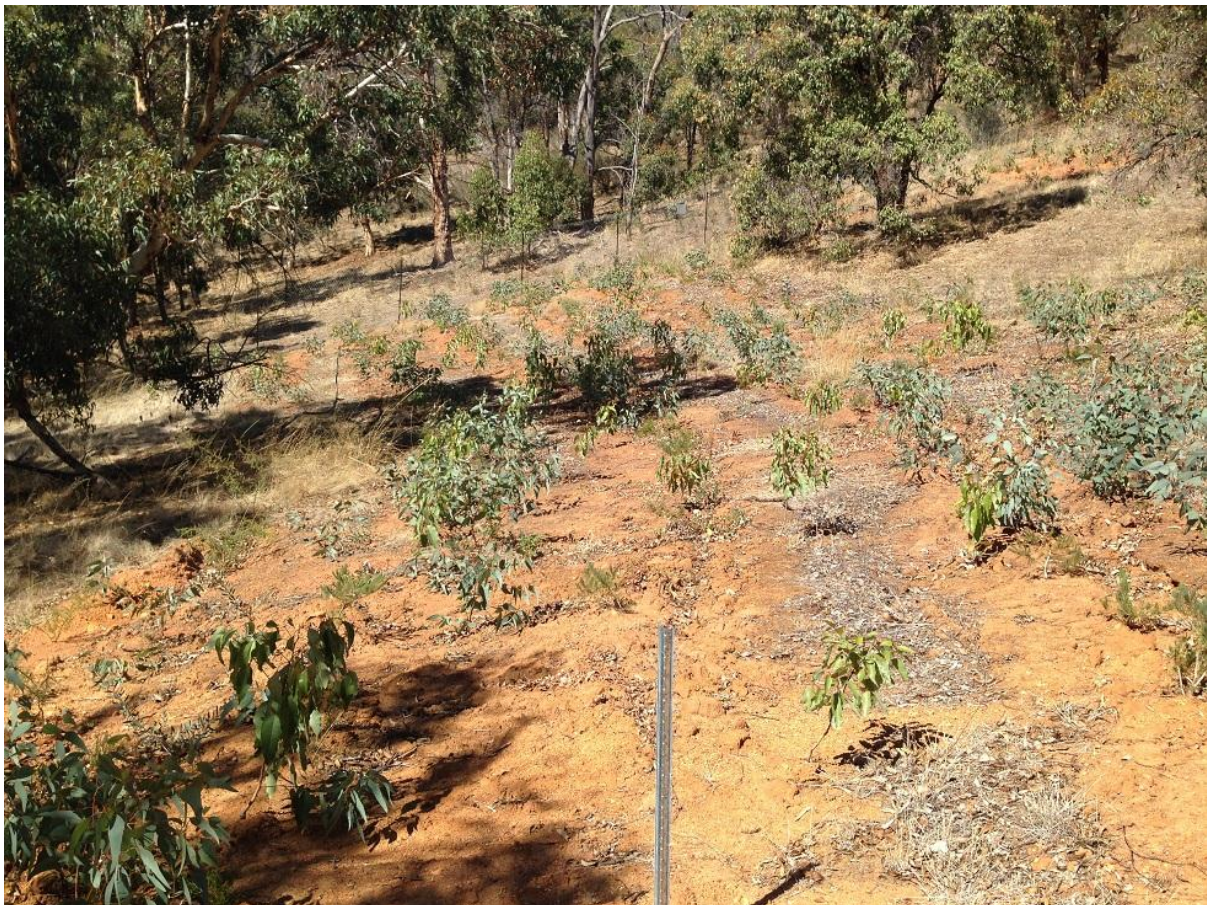
Figure 3 Site 4 – Transect # 3

Since the initial installation the following maintenance activities have been undertaken at Site 4:

- Fence repairs (August 2013);
- Weed control in autumn 2014;
- Additional fencing was erected on both sides of the middle track during April 2014. This was necessary because members of the public were leaving the gates open on the middle track through which kangaroos were entering the site; and
- Planting of 14,800 seedlings in July 2014.

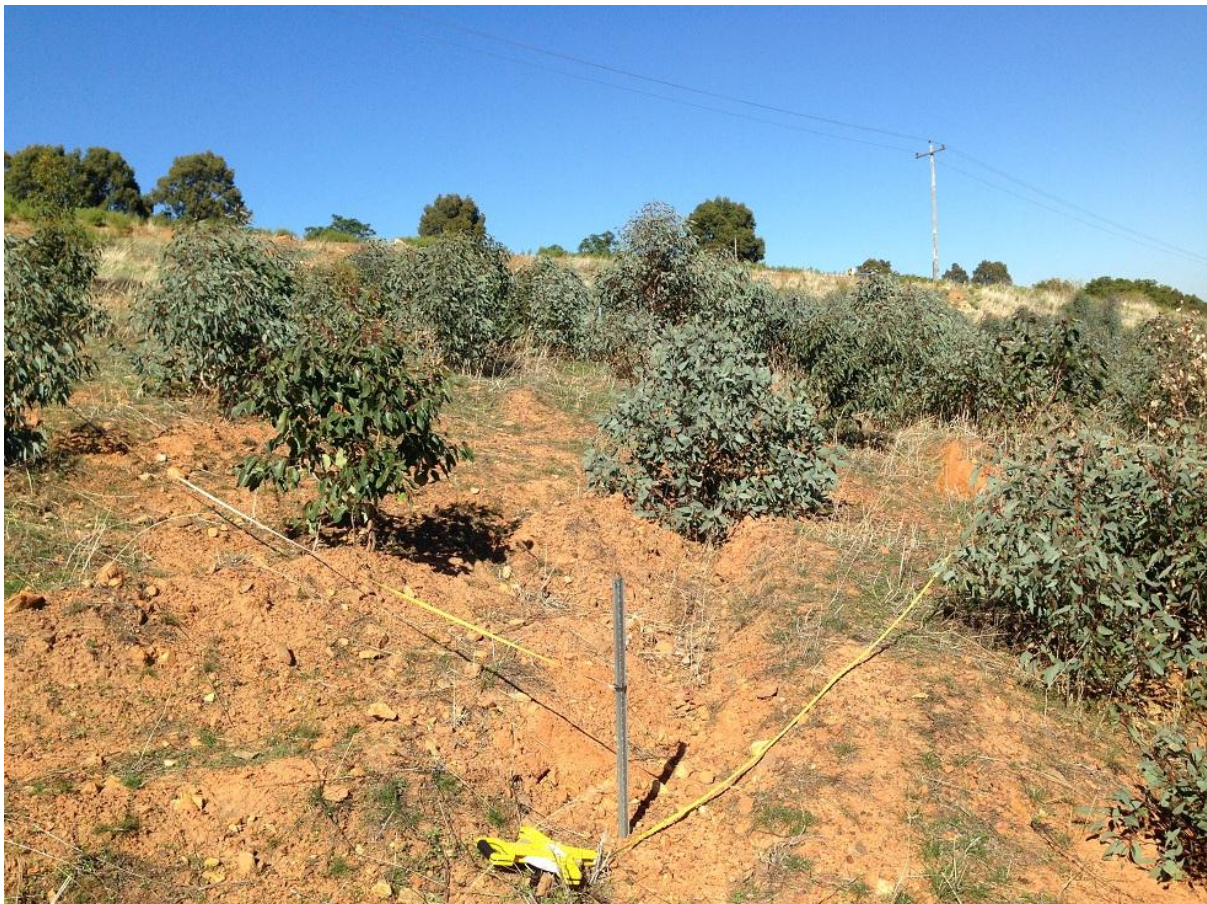
Kangaroo herbivory significantly reduced plant survivorship at Sales Office A during the first year after planting. Due to the location of the site near residences and a lookout for the Avon River, a fence has not been erected to further protect the plants as this would reduce the aesthetic qualities of the area. No further revegetation works have been undertaken on the site, as kangaroos will continue to eat shrubs and therefore continually impede revegetation success. Tree species have established from the initial revegetation efforts and continue to grow without being grazed. The weeds have been allowed to grow on the site to stabilise the topsoil as the site is on a steep slope and erosion was noted in the first year after planting.

Figure 4 Sales Office A – Quadrat # 2 Showing Strong Growth of Eucalypts

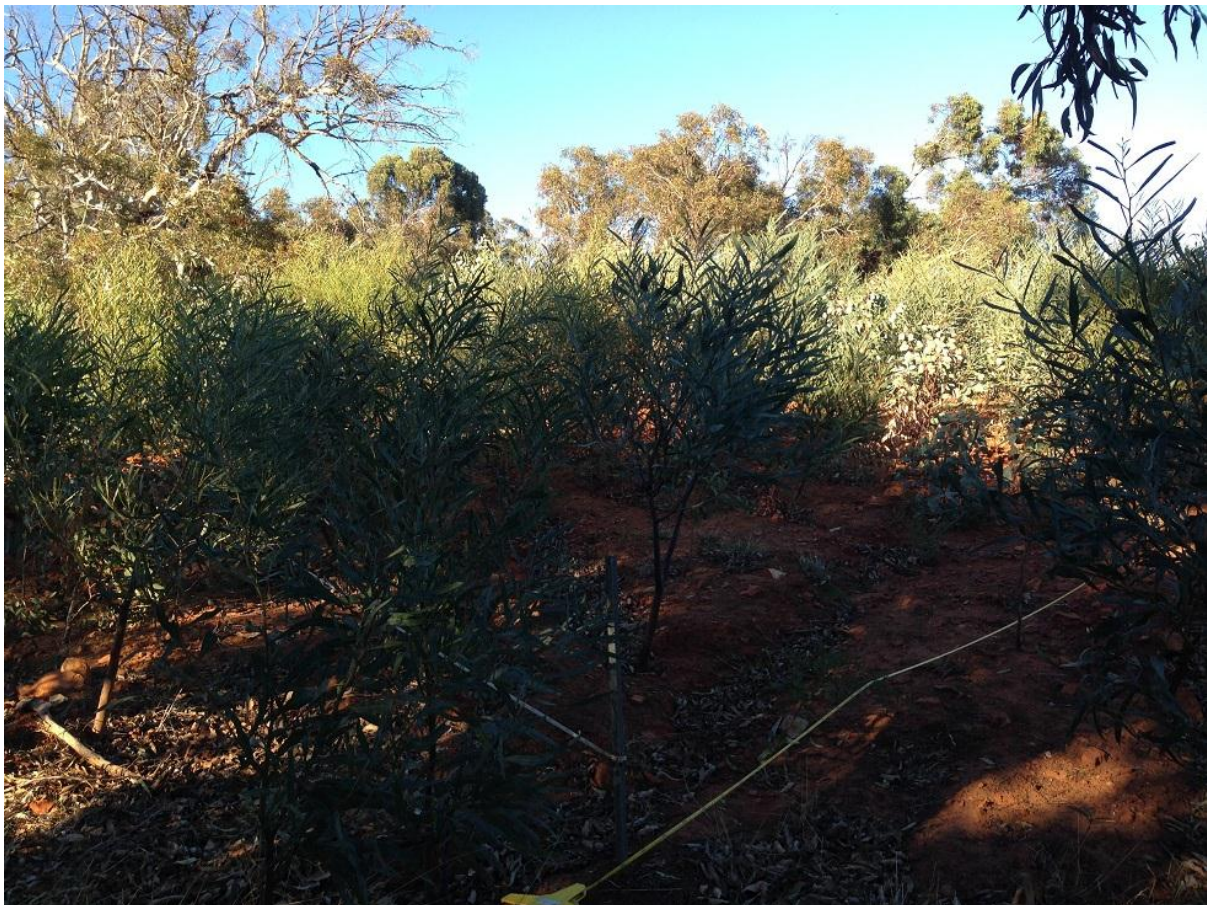
Since the initial installation the following maintenance activities have been undertaken at Sales Office B:

- Weed control in autumn 2014; and
- Planting of 8,000 seedlings in July 2014.

Figure 5 Sales Office B – Quadrat # 3 Showing Good Plant Growth
